### SECTION III

SERVICE BULLETIN NUMBER 1

#### SERVICE BULLETINS

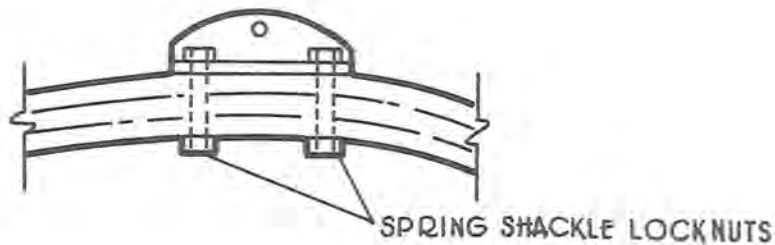
Locknuts on the Spring Shackles will loosen with use if not properly tightened.

Before Snowmobile use, Dealers should verify that Spring Shackle Locknuts are torqued to 40 ft. - lbs.

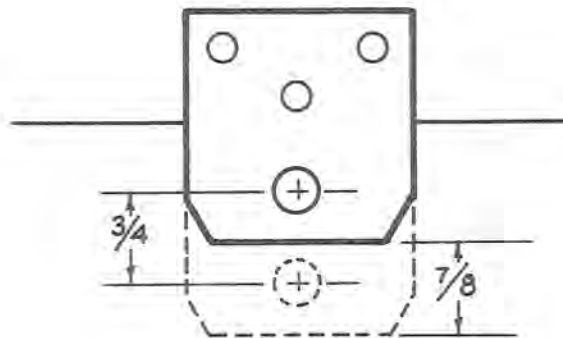
The three Bogie Assemblies may be raised  $3/4$ " for added Snowmobile stability. The Bogie hangers should be trimmed off  $7/8$ " for added ground clearance if Bogies are raised. A slight loss of climbing ability may be noticed.

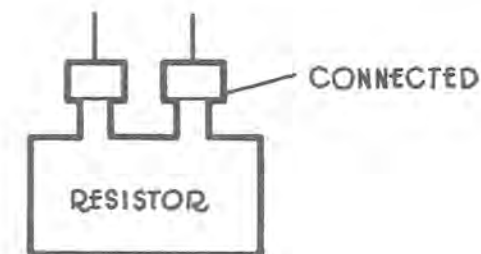
Resistor Connected

Dim lights on some manual start Firebird Models using GE 44-16 light bulbs can be corrected by bypassing the resistor. The resistor is mounted on the aluminum body forward of the engine. One of the two female terminals must be replaced by a male terminal for ease of connection. The resistor has been removed from later models.

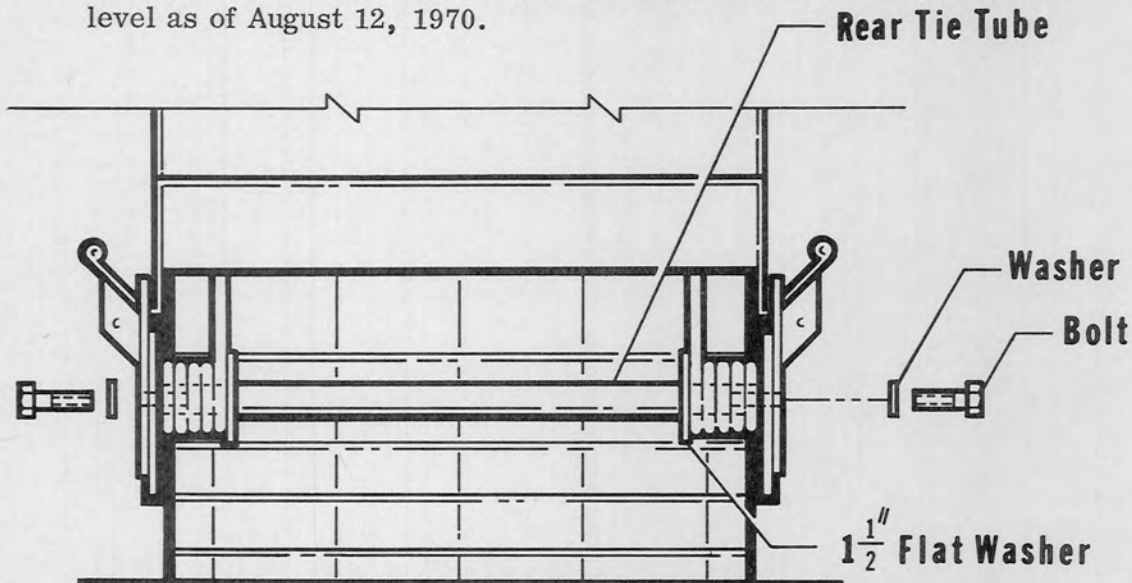
REAR VIEW

As a precautionary measure, the following operation can be completed on all 1971 Snowmobiles purchased before August 12, 1970.

Loosen rear tie tube bolts backing them out approximately 1/4". Push spring and flat washer towards outer edge of chassis. Place a few drops of Loc-Tite stud lock on the exposed portion of bolt treads. Re-tighten tie tube bolts. This operation is being performed at the production level as of August 12, 1970.

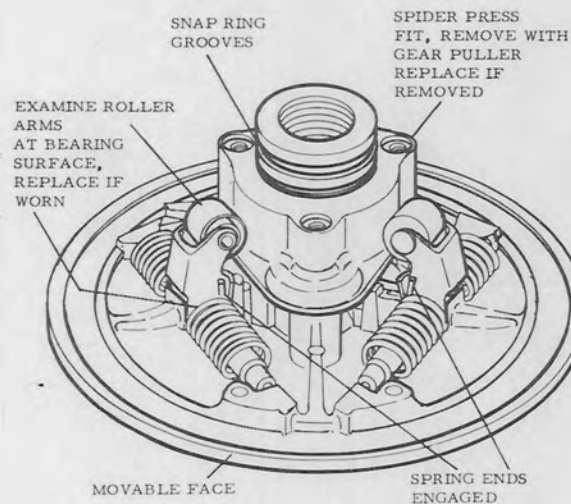
2-B-3 Removal of ramp plate exposes roller arms, springs, pins, bushings. (figure 2-B-3) Clean thoroughly and service as required. Replace all worn parts. Use complete service kits for springs or roller arms. Do not combine new and used parts of the same kind. Any indication of wear requires replacement.

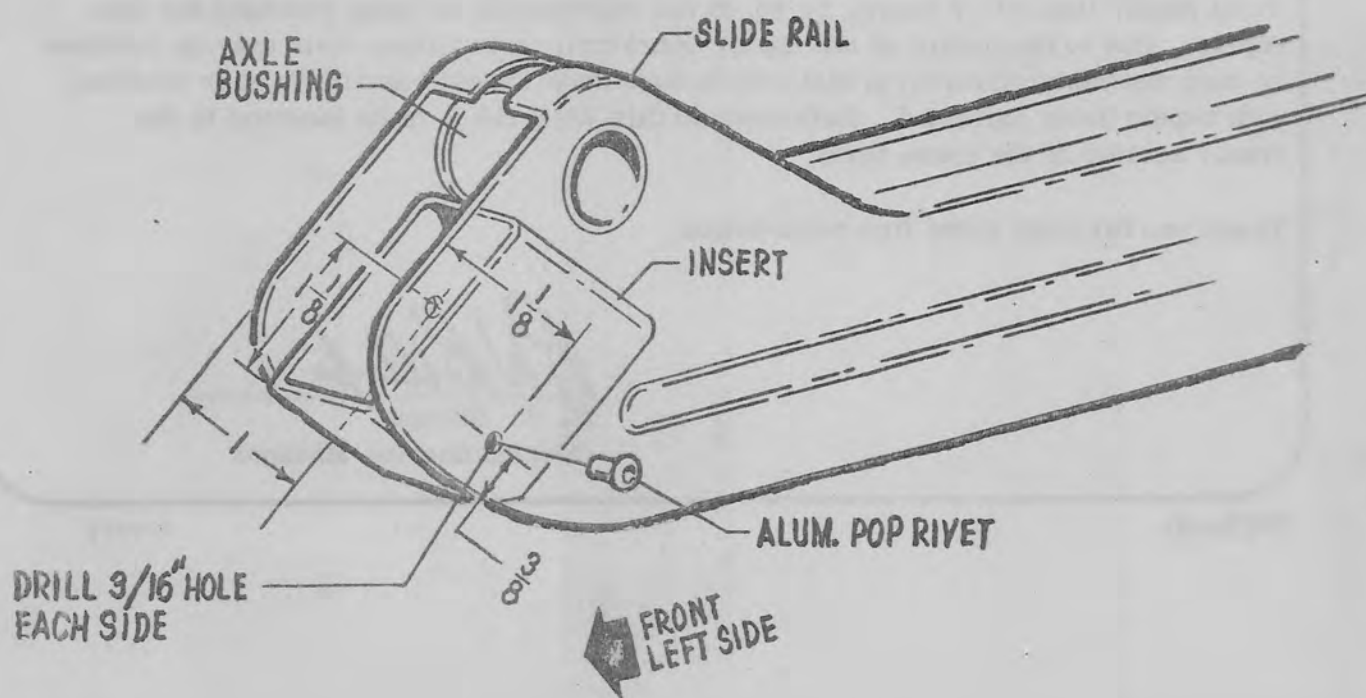
**Repair action for slide rail insert:**

In order to preclude the possibility of any track damage being experienced due to the track flexing in operation causing non-destructive gouging between the drive lugs, rail inserts are being provided direct to each Distributor for forwarding to Dealers having units that need to be modified. Installation details are provided on the reverse side of this Bulletin.

Note: Be sure the slightly ground corners of the insert are on the exposed side and are to the rear of the rail.

3. The insert should be positioned with a hammer so that the rear or backside of the insert is solid against the steel front axle bushing in the rail.
4. Hold the insert firm by clamping with a pair of vise grips on the outside forward edge of the rail.
5. Center punch and drill one 3/16" hole through each side of each rail per the sketch.
6. One aluminum pop rivet with "1/4 inch grip" in each hole is to be used to permanently fasten the insert. Remove vise grips.
7. Reinstall the assembly.
8. Adjust track alignment and tension.
